SOUTHWEST ELEVATION/SECTION
N.T.S.

*Plan of
Orient Point
Lighthouse*

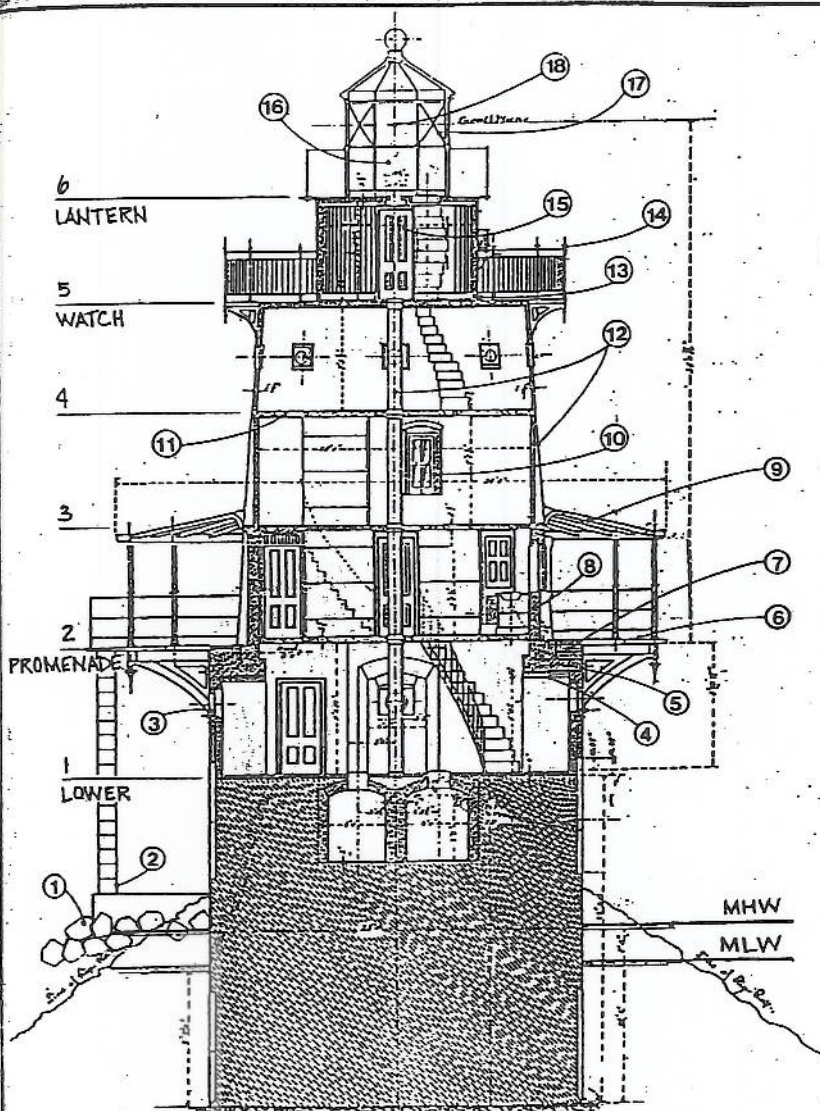
1. No mooring or boarding facilities are provided in the basin. Large endanger craft and threaten the safety of Coast Guard personnel.
2. Access ladder to gallery attached to perimeter of deck; therefore th access by unauthorized individuals.

3. Abandoned pipe, submarine cables and conduits penetrate the caisson cables chased through bulkheaded porthole at east quadrant. Some abandone and plugged.

4. Horizontal and vertical cracking and disbonding of thick, brick mase ice jacking as a result of seawater entering voids at the gallery level.
5. Cylindrical cast iron caisson bearing on rock and ballasted with cor structure. Several large diagonal cracks and partial repair plate observ splits at caisson flanges near top, especially at northern quadrants, ap

6. Radial cracking of cast iron exterior deck plates at gallery as a r associated with outward movement of upper portion of caisson.
7. Superstructure bears on thick, brick masonry walls which line the c. caisson and superstructure plating and masonry below filled by cast-in-p crack occurs along the face of the superstructure permitting water to en

8. Exterior cast iron wall lined with brick masonry laid up in common l
9. Original cast iron, curved roof beams replaced with structural shap Asbestos lumber presently comprises the roof decking.

10. Windows bulkheaded with 3/4" plywood fitted with hooded ventilators bolts and 2x4 strong backs.
11. Stairway bulkheading and fourth floor decking are corroded and dete structure from the watch level above.

12. Superstructure rises on exterior cast iron walls and an interior ir interior floors from levels 2, 3, 4, and 5 (watch). Floor decks made of integral flanges and overlayed by timber decking.

13. Upper portions of structure serve as roost for cormorants. Exterio fouled with excrement..
14. Top railing and several decorative finials missing from rail assemb

15. Wood panel "exterior" door at watch level not tight, allowing water levels below.
16. Full height curved, exterior door cannot be opened; cam action latic engaged to secure door.

17. Several bronze retaining strips which secure lantern lites are missi deteriorated.
18. Original lantern removed and replaced with contemporary model.
